Barkee Inspection Services, Inc.

ROOF SYSTEM

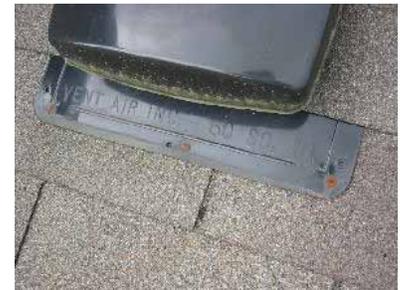
ROOFING CONDITION:	Roofing repairs are needed to prolong the overall life of the roof and to prevent moisture entry = Recommend further evaluation/repair by a licensed Roofer.
RIDGES:	Good.
INSPECTION METHOD:	Walked upon the rooftop.
ROOF PITCH (slope):	4:12.
STYLE:	Gable.
ROOFING LAYERS:	One.
APPROXIMATE AGE:	This roof appears to be 6 to 9 years old.
ESTIMATED LIFESPAN:	The statistical life average of this roofing product is 15-18 years.
ROOFING MATERIAL:	Composition Shingles.
ROOF COVERING STATUS:	Serviceable and is still within useful lifespan.
SOME OF THE SHINGLES:	Some of the shingles showed the following conditions: moss growth, cracking.
EXPOSED ROOFING NAILS:	Roofing nail heads are exposed without the proper sealant covering: (10-20) = Recommend patching with appropriate sealer.
