## Barkee Inspection Services, Inc.

## PLUMBING SYSTEM

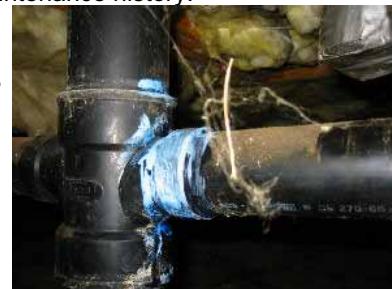
**Evidence of waste pipe leaks in Crawl Space under Master bath shower = Have repaired by licensed plumbing contractor.**
